## **Thunderbird TTY70 Hauler Incident Major failure as a result of the drag striking the cab.**

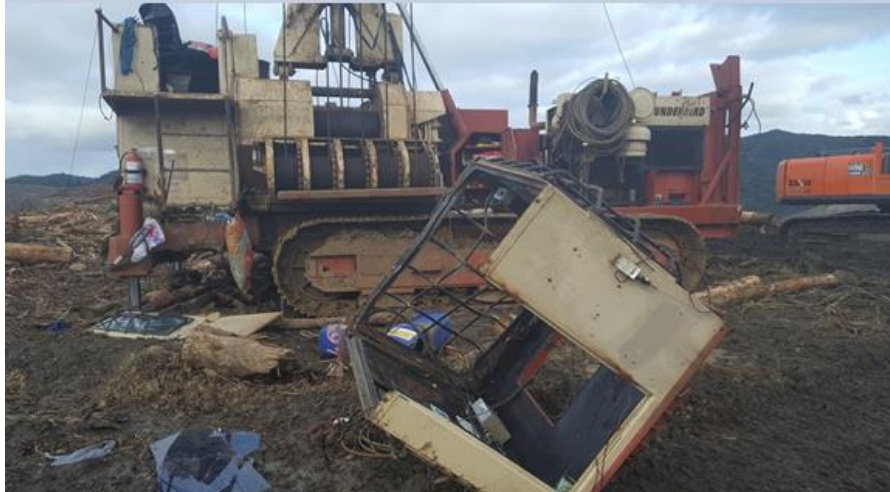
An experienced and qualified hauler operator was in the process of hauling in a drag consisting of three logs attached to a single strop running from an Acme MSP carriage. As the drag came up over the edge of the landing the drag swung like a pendulum and struck the cab of the Thunderbird TTY70 Hauler with force.

As a result of the cab structure absorbing a significant amount of force it was torn from the hauler and the operator has ended up on the floor of where the cab had been. The operator sustained relatively minor injuries.

- Operating the inhaul in the wrong gear (3<sup>rd</sup> gear was too fast).
- Extracting the drag with 8 meters of main-rope (this contributed to the force of the impact).
- Inattention: The hauler operator failed to monitor the position of the Acme carriage on the skyline due to allowing himself to be distracted by observing the main-rope winding onto the drum.
- Failure to excavate the hauler chute in front of the tower to enable friction control of drags as they come up and onto the landing.
- Inadequate guarding to protect the hauler operator cab from being struck by logs.

- Circulate the full HFMNZ investigation report (redacted copy) to all regions / cable logging contractors.
  - Ensure all cab fasteners used to join a two piece cab are present and in good condition.
  - Findings from the contractors engineer used, that provide forward cab protection will be shared.
  - As best practice and during set up, hauler landings should be assessed for options to create friction control by way of excavating the hauler chute.
-
