Extractives industry

2020/21 Q3

January to March

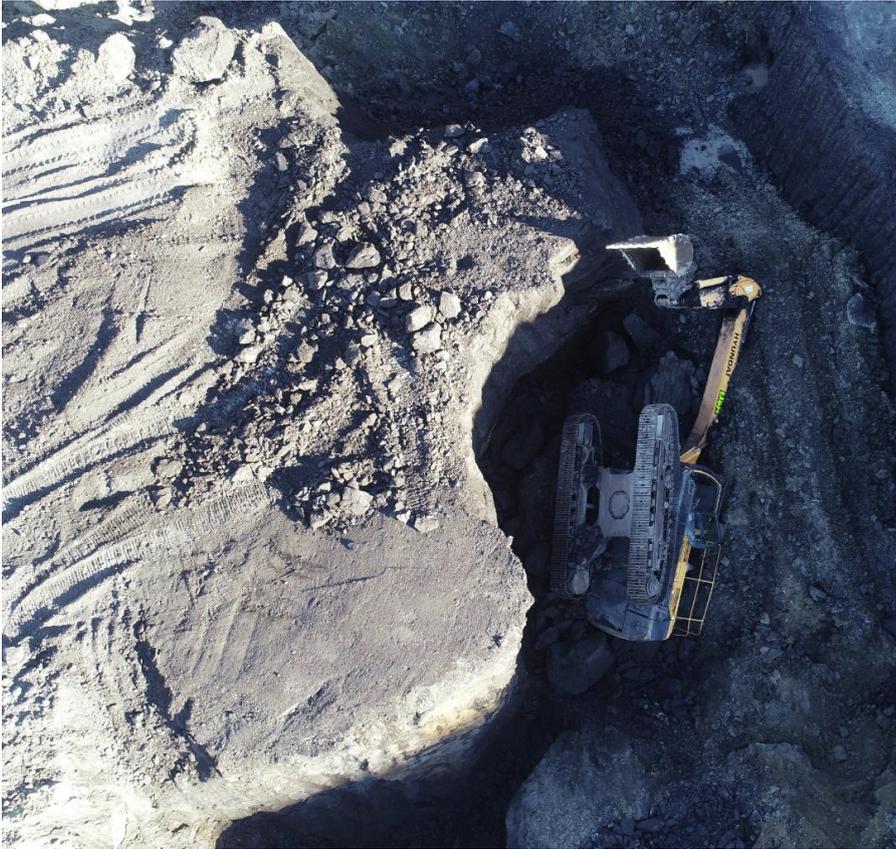
FIGURE 12: Incident scene photographs

INCIDENT DATE	SUMMARY	CONSIDERATIONS
Jan 21	50-ton excavator was mining coal, trammed back to set up the digger platform better. In doing so one of the digger tracks were close to the edge of the bench and the edge collapsed and the digger rolled off the bench onto the cut below, coming to rest upside down. The cab side was undamaged and the operator was able to walk out un-injured.	<ul style="list-style-type: none"> - Tips, ponds and voids - Job planning - Risk assessment - Workplace inspection - Design - Supervision - Training

The excavator operator positioned the excavator within 1m of the coal bench edge directly over top of an unidentified overhang. The ground pressure applied to the overhang from the excavator positioning the offside track on top of it has caused the wedge to fail, causing the excavator to fall from bench.

- Inadequate processes for inspecting coal during pre-shift inspections when underground workings are present.
- The JSEA had not been updated or reviewed for working in the area for 10 days.

- Training does not identify all potential hazards associated with underground workings, specifically cleaning out drives.
- The excavator operator did not identify any hazards associated to their work area, less than adequate individual risk management tools used (that is, take-five).

- Risk management practices have not been adequately completed by operational staff.
- Acceptance of individuals failing to utilise risk management tools.

- The coal within the area of the wedge failure is hard and contains poorly developed sub-vertical conjugate joint sets. This weakness in the coal seam is a contributing factor to the wedge failing.

- The additional loading resulting from impact of digger breaking a coal lump with the bucket was enough to exceed the shear strength of the bench crest resulting in a wedge failure bound by high angle conjugate joints.

- Standard Operating Procedures should be written where possible
- work areas are designed to control the hazards
- that work areas are monitored to ensure all developing risks are identified

- roll-over protection is fitted to all cabs including excavators, and ensure operators wear seat belts and keep doors closed
- that there is an emergency response to a roll over, including provision of equipment or persons to ensure a safe recovery of the operator from the machine in any circumstance
