Extractives industry

2021/22 Q2

October to December

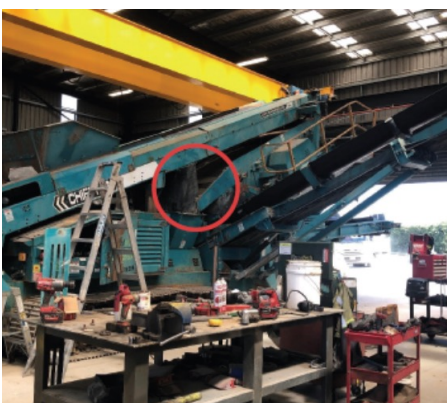
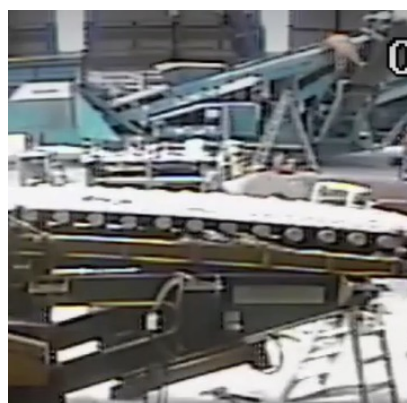
FIGURE 12: Incident scene photograph

A worker was injured while completing routine maintenance on mobile plant. The worker had used a ladder to access the screen and was climbing along the outside along the mobile plant. While attempting to move across the equipment the worker lost their footing, resulting in them falling approximately 2.1m. The worker suffered a rib fracture and required stitches to their leg.

- Can the job be done without exposing persons to the hazard (eliminate)? This can often be achieved at the design, construction planning and tendering stages.
- If elimination is not practicable then steps should be taken to isolate people from the hazard. This can be achieved using safe working platforms, guardrail systems, edge protection, scaffolding, elevated work platforms, mobile scaffolds and barriers to restrict access.
- If neither elimination nor isolation are practicable then steps should be taken to minimise the likelihood of any harm resulting. This means considering the use of work positioning systems or travel restraint systems, safety harnesses, industrial rope access systems and soft landing systems.

- change the way a task is carried out when a safer alternative is identified, and encourage their workers accordingly
- ensure suitable equipment, including PPE, is available and workers have adequate training for its use
- ensure workers are trained to identify fall-from-height hazards they might encounter and have appropriate supervision
- review elevated screen plants and conveyor systems to identify all reasonably foreseeable hazards, including specific tasks that expose workers to the risk of falling from height
- conduct a risk assessment to identify hazards and reduce worker exposure, so far as is practicable
- review and, where necessary, update site procedures to ensure controls are adequately documented in the safety management system, including the need for specific risk assessments when working at height.

Mobile screening plant designers, manufacturers, importers and suppliers should conduct a risk assessment of the tasks workers are likely to undertake on the plant to identify where they may be exposed to the identified hazards, including the risk of falling from height.
