SCUBA CYLINDERS MANUFACTURED FROM ALUMINIUM ALLOY 6351

AT RISK CYLINDERS

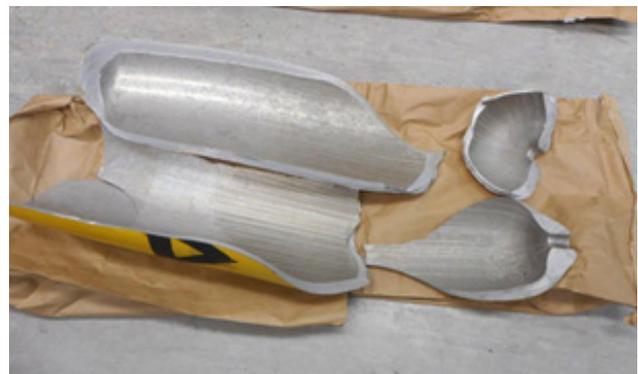
Cylinder failure is caused by sustained load cracking in the neck and shoulder area of the cylinder.

The most recent incident, in August 2016, Sydney, NSW, was a Luxfer SCUBA cylinder that ruptured during filling (see picture). The rupture caused serious harm including partial amputation of a leg. The incident is currently under investigation by SafeWork NSW.

All Periodic Testers and Approved Fillers must be vigilant in making sure at-risk cylinders are up-to-date with annual visual examinations before filling. As always, check for surface gouging, cuts,

dents or damaged fittings, and if in doubt, do not fill the cylinder.

If early signs of sustained load cracking or a neck crack are identified, the cylinder must be condemned to prevent it reaching a critical state.
