May 2022

3000 PSI water blaster gun – explosion

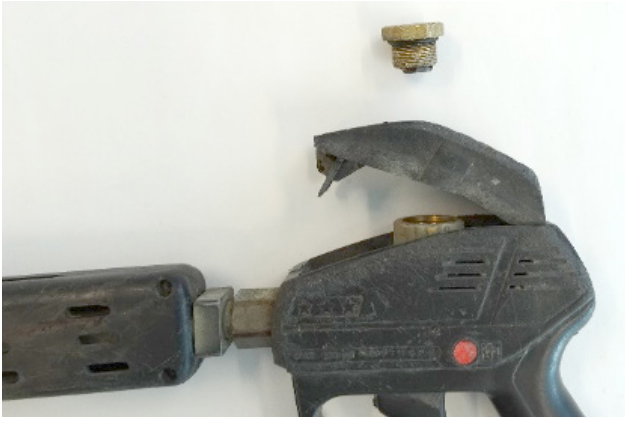
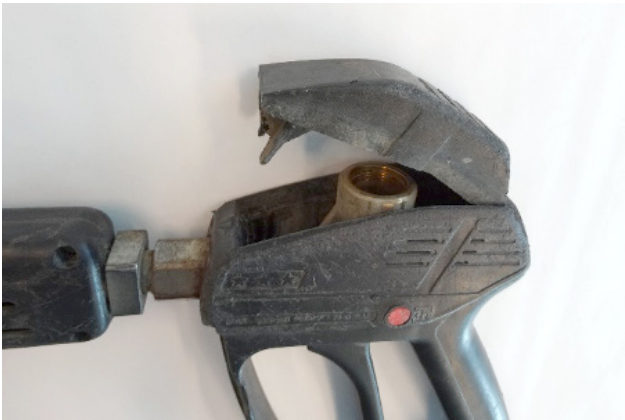
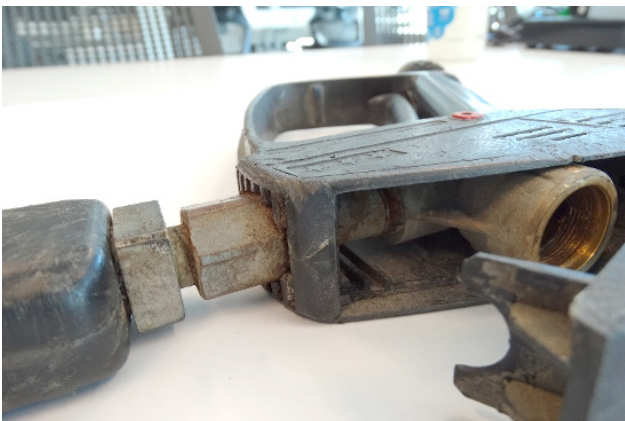
The water blaster gun involved in the incident has a threaded bung (bolt) at the top, that is screwed into the brass body. While in use, the threaded bung fired out of the water blaster gun with a force that blew the operator backwards.

WorkSafe New Zealand engaged experts to understand why this incident occurred. After ruling out a malfunction of the machine itself, a definitive cause for the bung ejecting under pressure could not be established.

The experts strongly suggested that bungs should never be removed from water blaster guns to either repair or maintain them, as it can create a risk of cross threading. A cross threaded bung allows for the potential for it to be ejected under pressure.

FIGURE 1: The water blaster gun involved in the incident, including the bung and threaded brass body of the gun

If an existing high-pressure water blaster gun has a bung, instead of attempting to carry out maintenance on the bung, or replace certain parts, we recommend that you dispose of the entire water blaster gun and replace it with a new one.

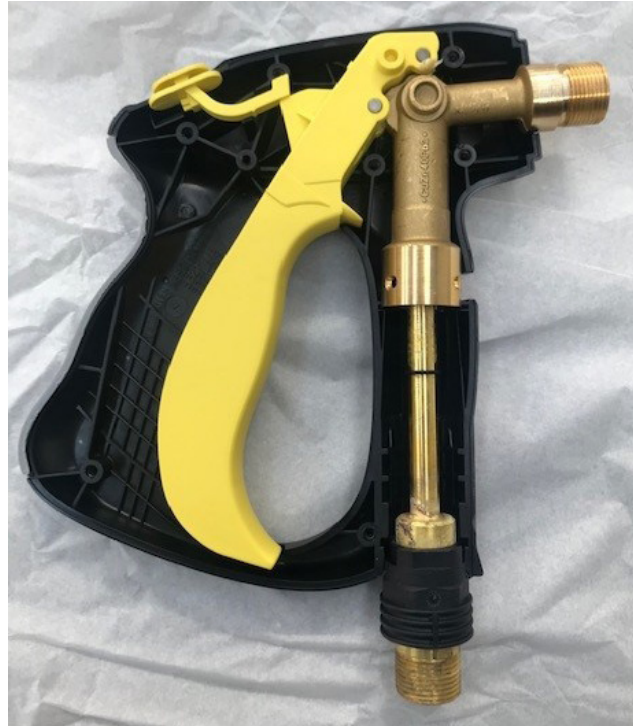
FIGURE 2: Example showing the internal structure of a solid manifold gun (gun without a bung) and trigger assembly

Solid manifold water blaster guns (gun without a bung, refer Figure 2 for example) are also available for purchase in New Zealand.
