Locations of asbestos in a residential dwelling

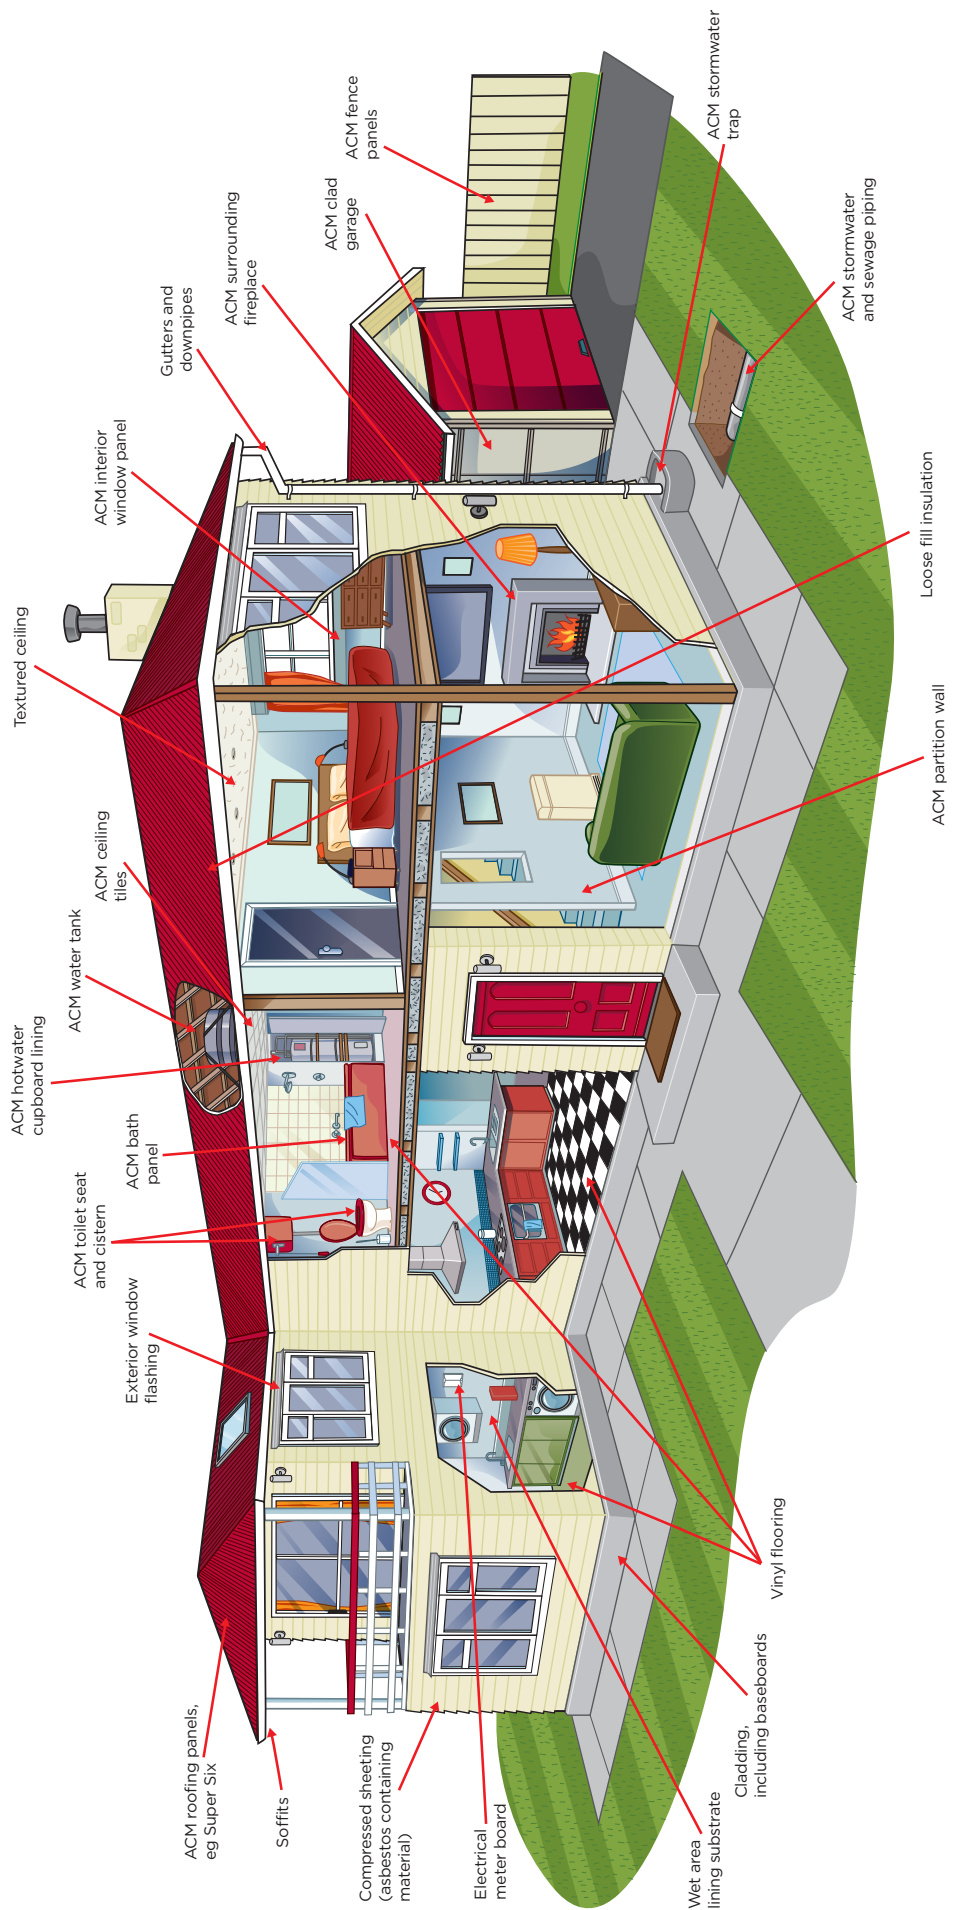
Check out the image on the back of this fact sheet to view other places where asbestos may be hiding in your building.

- The walls behind stoves in kitchens
- Interior and exterior walls
- Flooring, especially lino flooring in wet areas (bathrooms, laundry, toilet, kitchen)
- Roofs
- Hot water tanks
- Insulation and lagging
- Gutters and downpipes
- Fireplace surrounds and chimneys
- Ceilings
- Electrical fuse boards
- Water pipes internally
- Around windows and door frames.
